**FINAL
Site Inspection Report
Biggs OB Site II**

**Environmental Remediation Services at Four Installation
Restoration Program Sites and
Military Munitions Program Sites at Fort Bliss, Texas**

Contract No. W91ZLK-13-D-0003

Task Order No. 0003

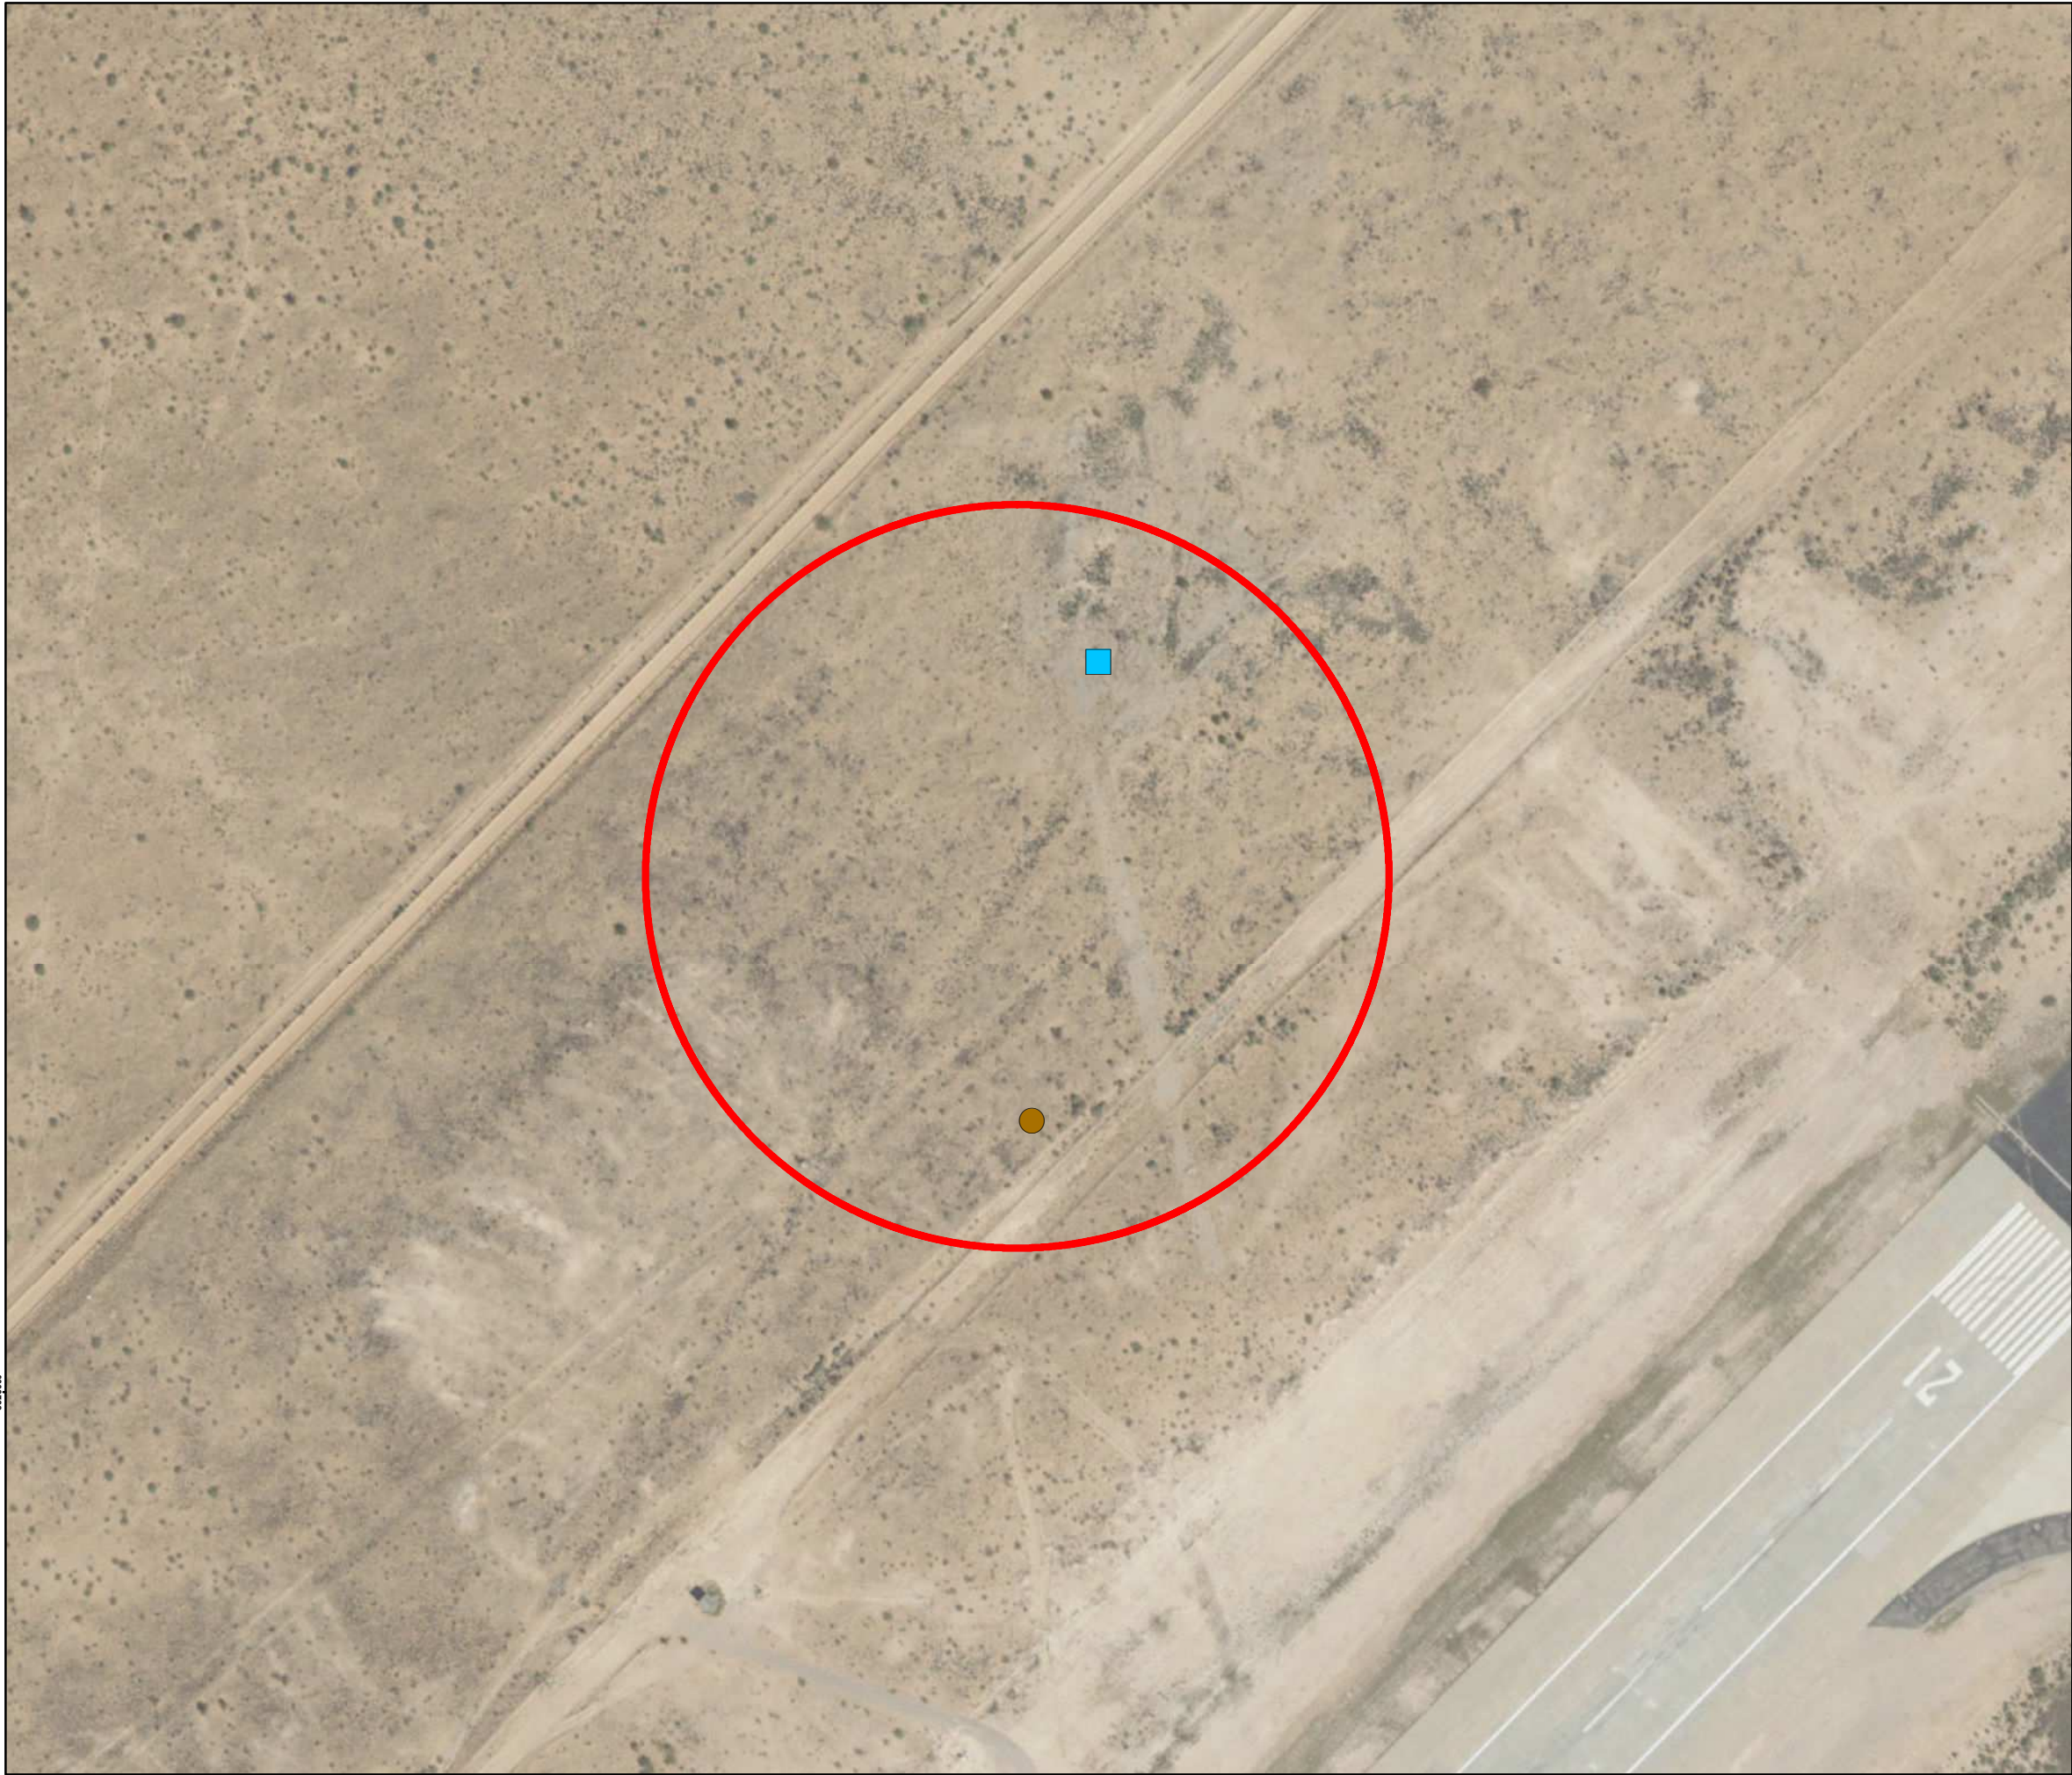
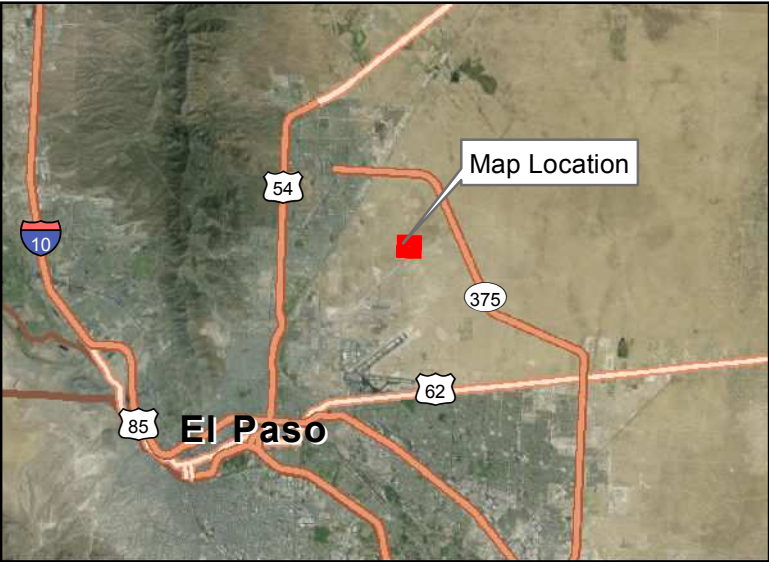
Figure 2-1

OB Site II is located approximately 600 feet to the northwest of the main BAAF runway (**Figure 2-1**). Based on previous findings, the site is estimated to be approximately 14 acres. The site is fully contained on BAAF property, access is restricted, and the area is secure. There is an access gate to the general area located approximately 1 mile to the west of the site and a dirt road located just north of the runway running parallel with the runway, which allows for access to this site. A confirmed former munitions disposal site, known as “OB/OD Site I,” is located 0.9 miles to the south of OB Site II.

Site Setting
Biggs OB Site II
Fort Bliss, Texas

5.3.4.1 *Physical Source Access Conditions.* OB Site II is located approximately 600 feet to the northwest of the main BAAF runway (**Figure 2-1**). The site is fully contained on BAAF property, access is restricted, and the area is secure. OB Site II is not currently active, and future land use at this site is expected to remain the same.

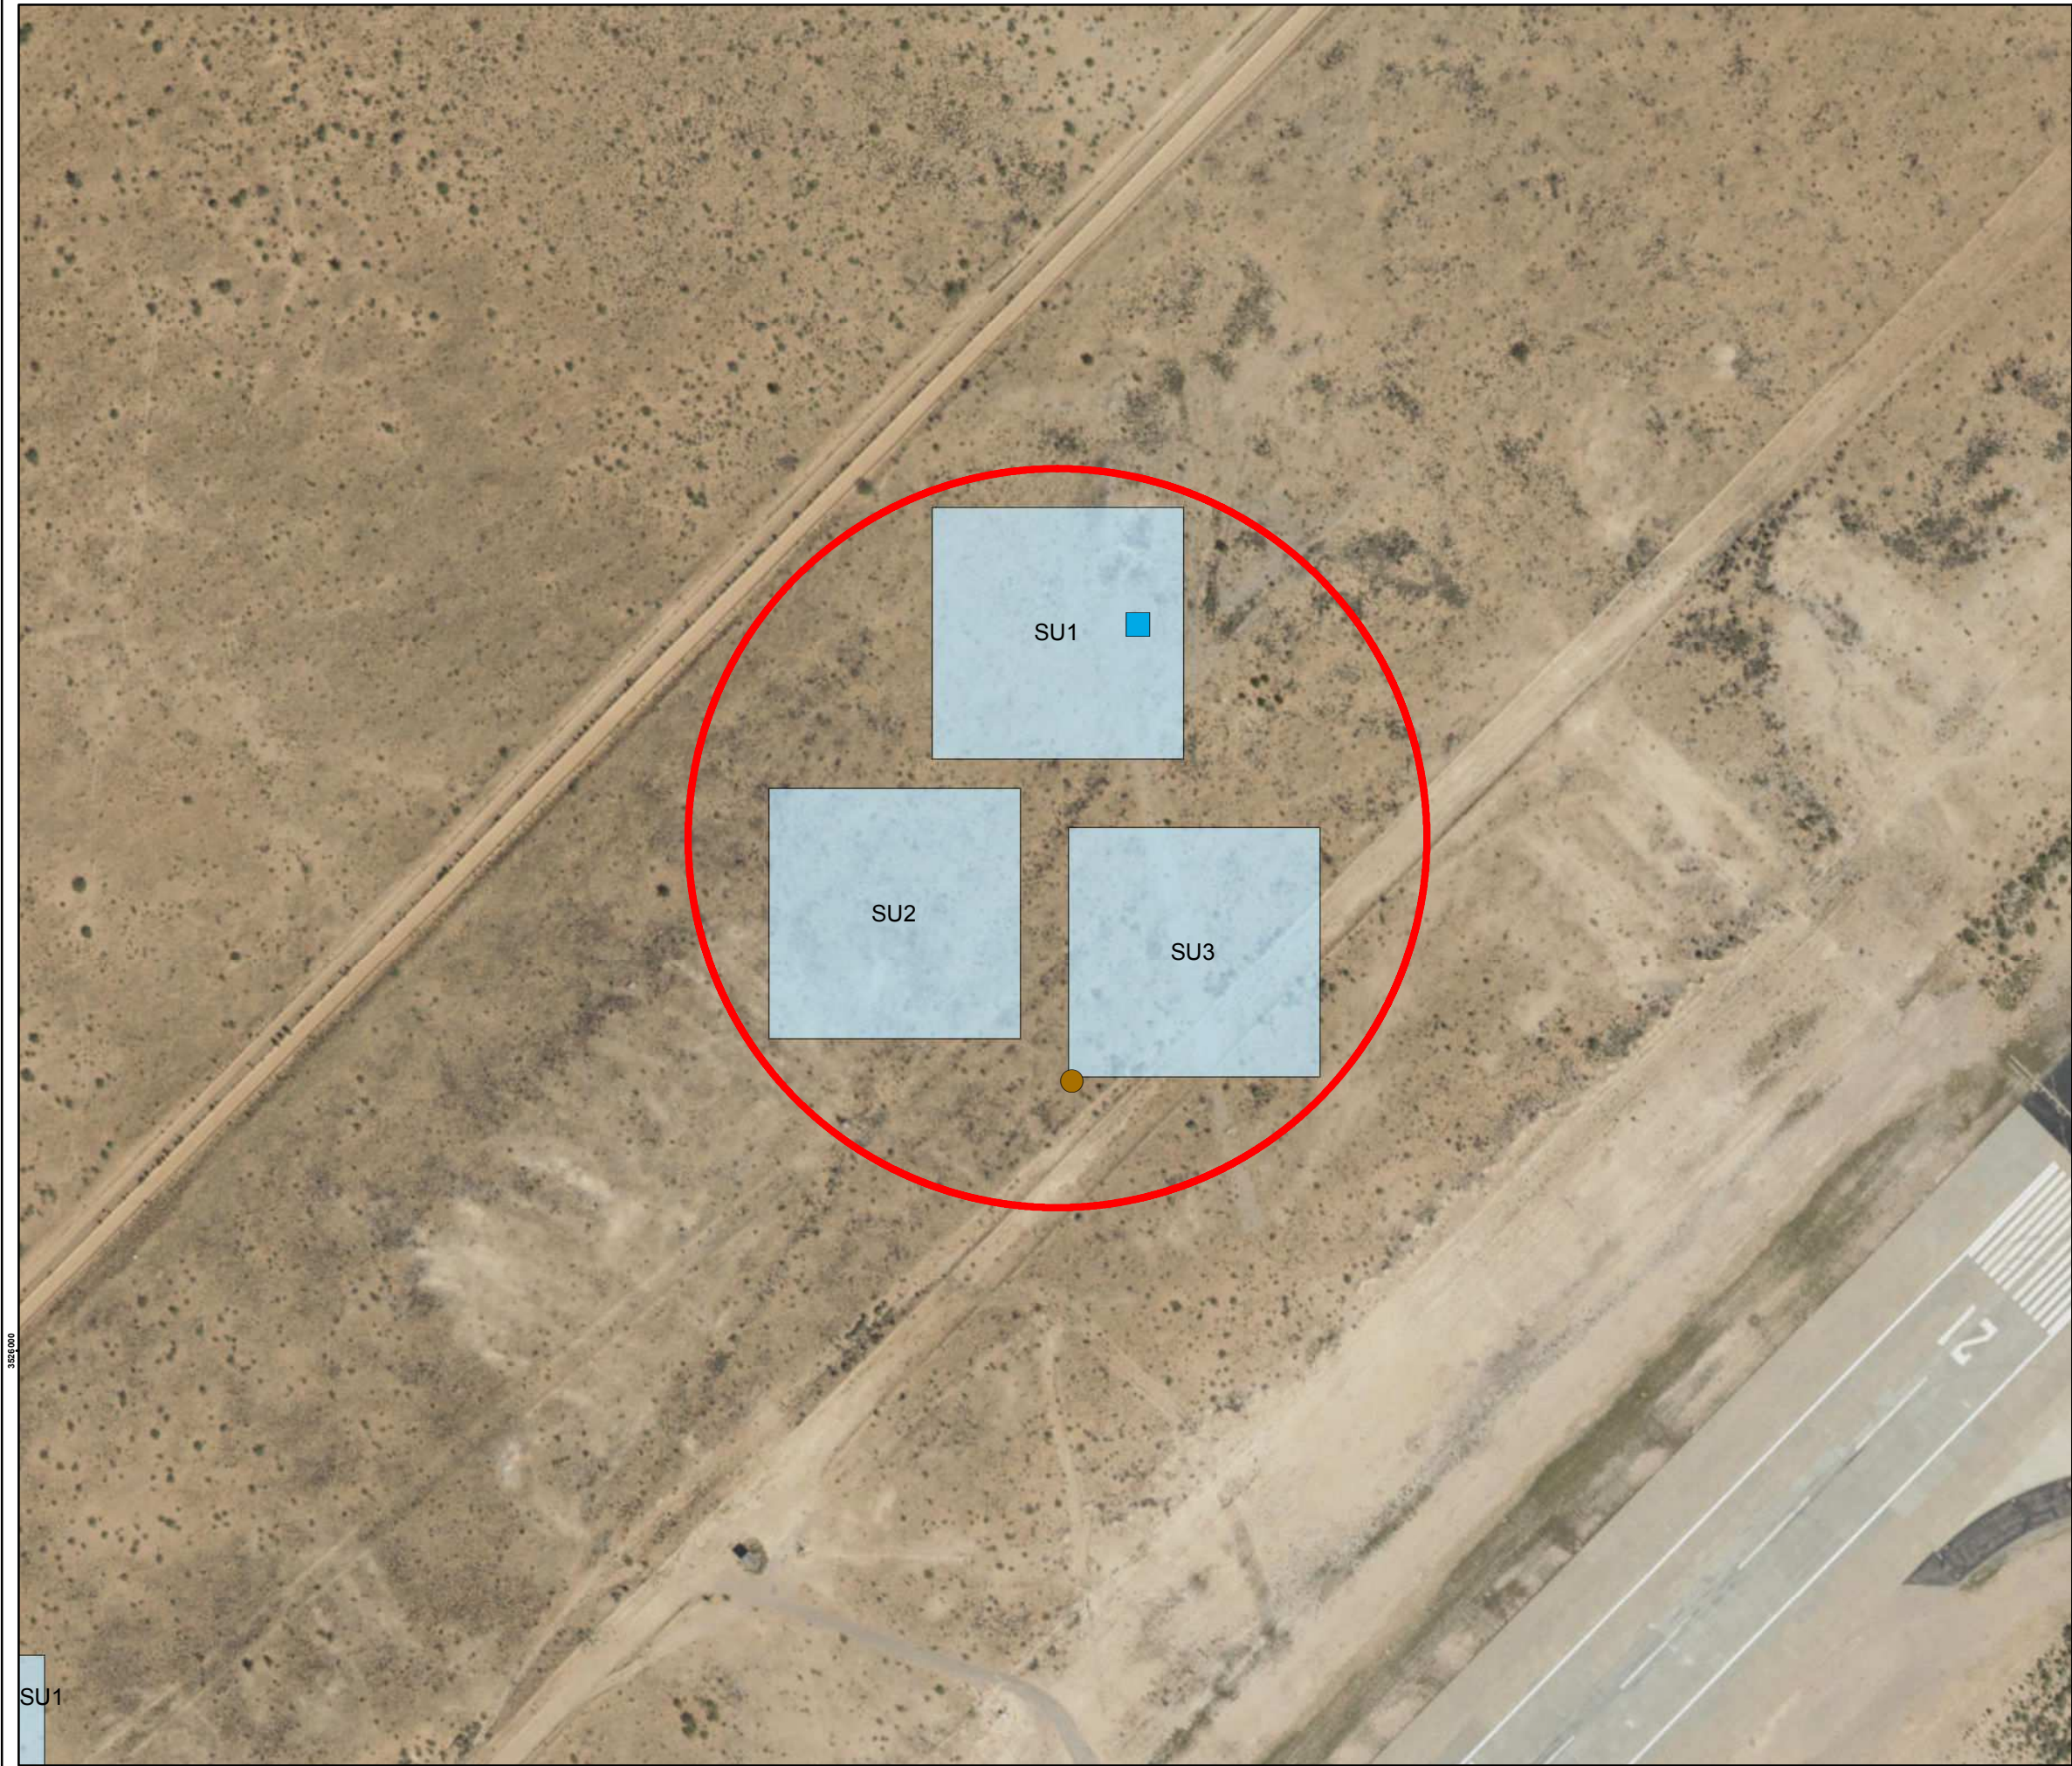
Figure 3-3

**MC Investigation Approach
Biggs OB Site II
Fort Bliss, Texas**

- Possible Pit or Trench
- Mound
- Site Boundary
- Sampling Unit

<p><i>Munitions Constituents:</i></p> <p>If the site was used as an OB area, disposal operations or degradation of MEC at disposal features may have resulted in MC being released to environmental media. If MC contamination is present, it may pose a risk to human and ecological receptors.</p>	<p>The principal question is “<i>Is MC contamination present at the site?</i>”</p> <p>The possible alternative actions resulting from the principal question are (1) take no further action, or (2) recommend an RI to characterize the nature and extent of the MC contamination identified.</p> <p>Based on the above, the project decision statement is: <i>Determine whether MC requires no further action or a remedial investigation.</i></p>	<p>Results of geophysical surveys.</p> <p>Field sampling data and laboratory analysis results for soil samples.</p> <p>Land use and receptors.</p>	<p>Boundaries of Biggs OB Site II defined on Figure 2-1.</p> <p>MC analytes and sample media limited to those listed in preliminary CSM (Table 3-1).</p> <p>There are no time constraints on data collection.</p>	<p>The parameters used to make conclusions regarding MC contamination will be the detected concentrations of MC analytes in collected soil samples.</p> <p>The related analytic approach and decision process are summarized in Figure 3-1.</p>	<p>Sampling and analysis shall achieve applicable MPC as stated in the UFP-QAPP, unless MPC failures can be adequately explained and/or justified.</p>	<p>Locate three (3) 300-foot-by-300-foot sampling units (SUs) across the site and collect incremental samples for MC analysis (Figure 3-3).</p>

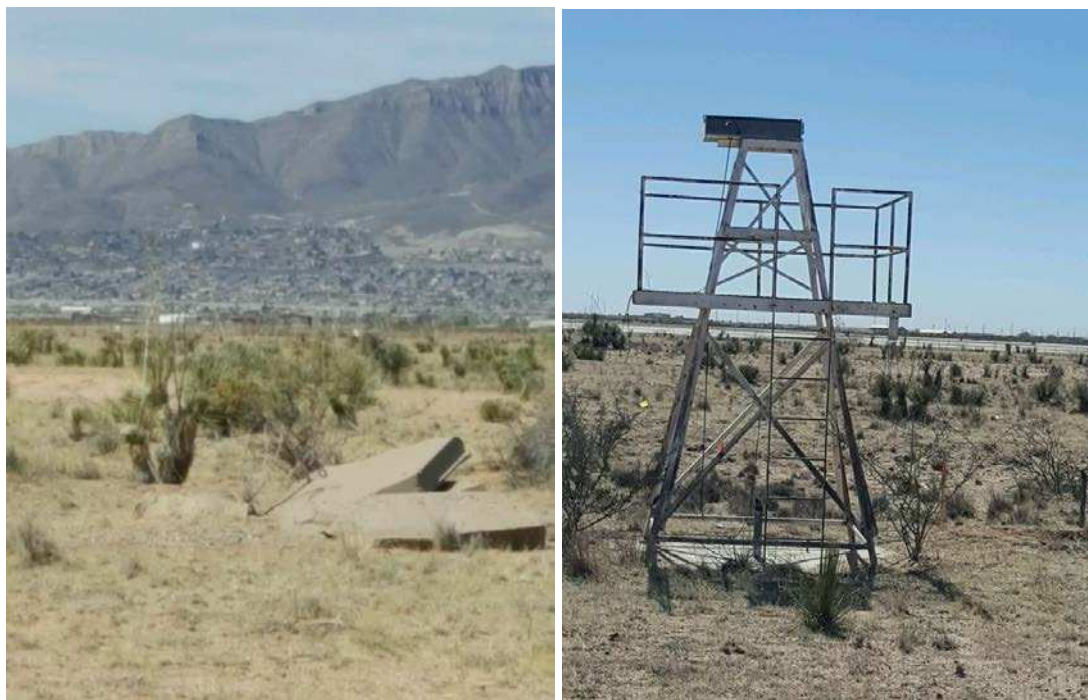
Exhibit 4-1: OB Site II Observations – concrete slab (left) and runway laser tower (right)

4.1.2.1 The SI field team performed 10 miles of DGM transects to assess the potential presence of MEC contamination at OB Site II. The transects were spaced 10 feet apart and covered the entire site and areas just outside the site boundary. One MEC item, a 40mm projectile, was found on the surface just outside the boundary at the southern edge of the site. OB/OD Site I is a confirmed former MEC disposal site located 0.9 miles to the south of OB Site II. While not certain, it is possible this MEC item might be related to disposal operations at that location or to other operations at Fort Bliss rather than to as yet unconfirmed disposal operations at OB Site II. The MEC item was turned over to Fort Bliss Explosive Ordnance Disposal personnel in accordance with the approved UFP-QAPP. The documentation for this transfer is included in **Appendix B**. No other MEC, MPPEH, or MD were observed during the field effort. Several site features were noted during the DGM surveys, but none were clearly related to munitions use. These features included buried cables, a large pile of aircraft debris, two concrete slabs/structures, and a runway laser tower (**Exhibit 4-1**).

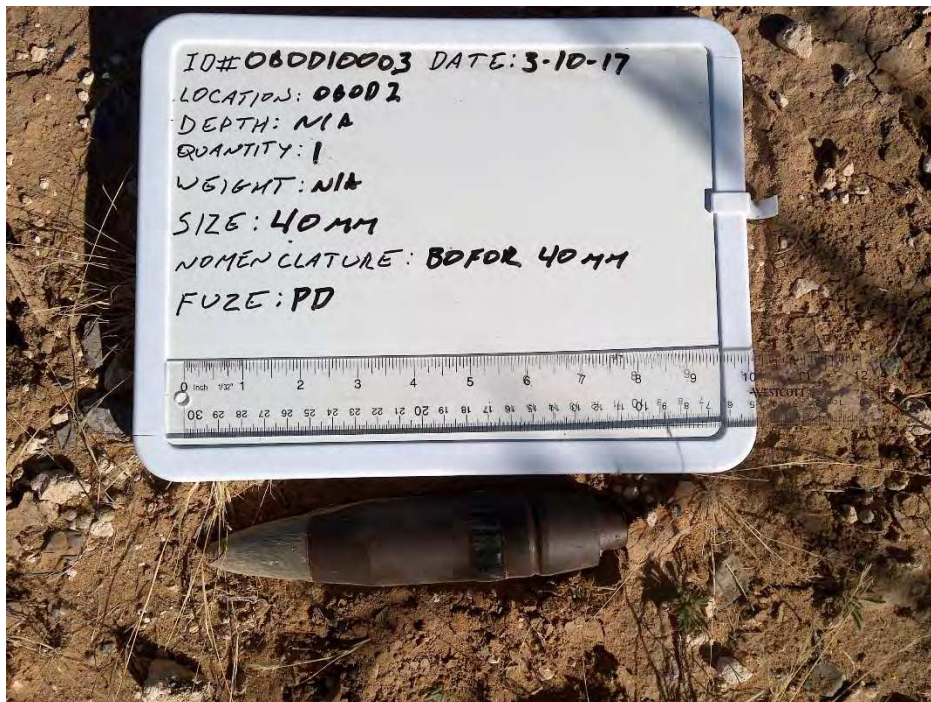
Item Number: 7	Item Description: 40mm Projectile, HE, MkII
Quantity:	1
Fuze Information:	Mk 27 PD
Filler Composition:	0.15 lbs. TNT
Found Where:	OB2
GPS Location:	31°51' 46.3290" 106° 22' 9.172"
Found When:	March 10, 2017
Found By Whom:	Team 1, Temple Coffindaffer
Condition Verified By:	George Payne, SUXOS
Date/Time RCO Notified:	March 10, 2017, 0945
Individual Contacted:	Ronald Baca, Environmental Scientist, PWE Environmental Division
Date Item Transferred to EOD for Destruction:	March 10, 2017

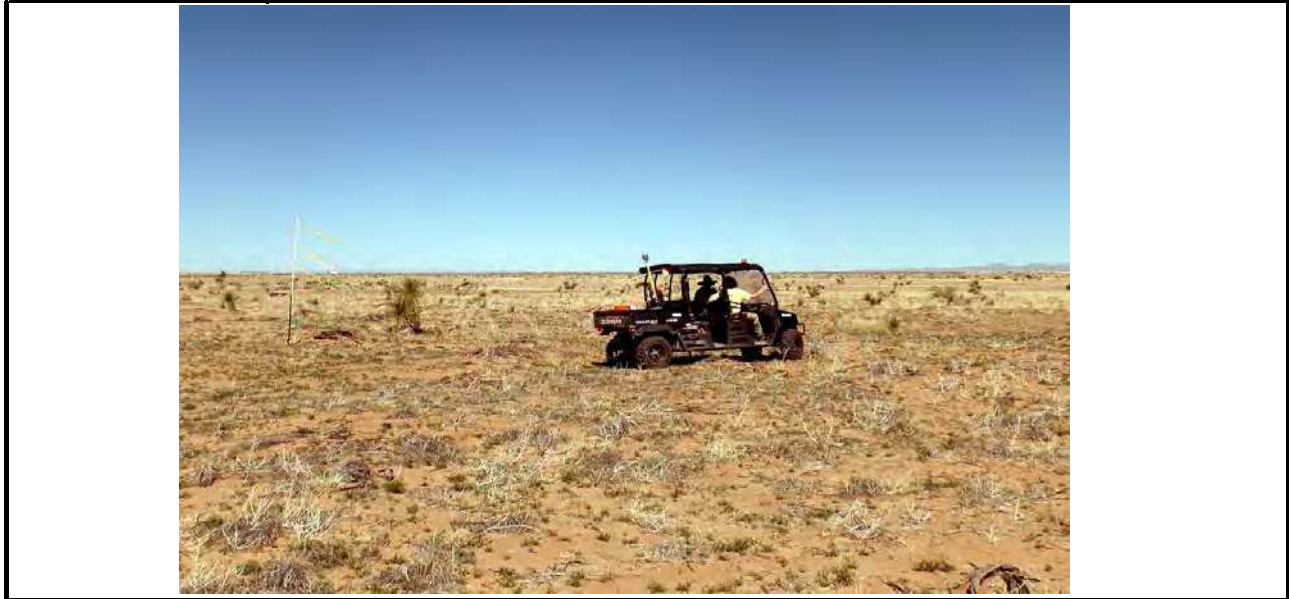
PHOTO NUMBER:	2	DATE TAKEN:	7-Mar-17
Description:	Geo Team Marking Transect Lines
